TP 1624

Marine Casualty Investigations

REPORT OF INVESTIGATION INTO THE SINKING OF A SMALL OYSTER FISHING BOAT IN WALLACE RIVER ESTUARY, NOVA SCOTIA, WITH THE SUBSEQUENT DEATH OF THE TWO OCCUPANTS, NOVEMBER 11, 1988.

REPORT No. 529

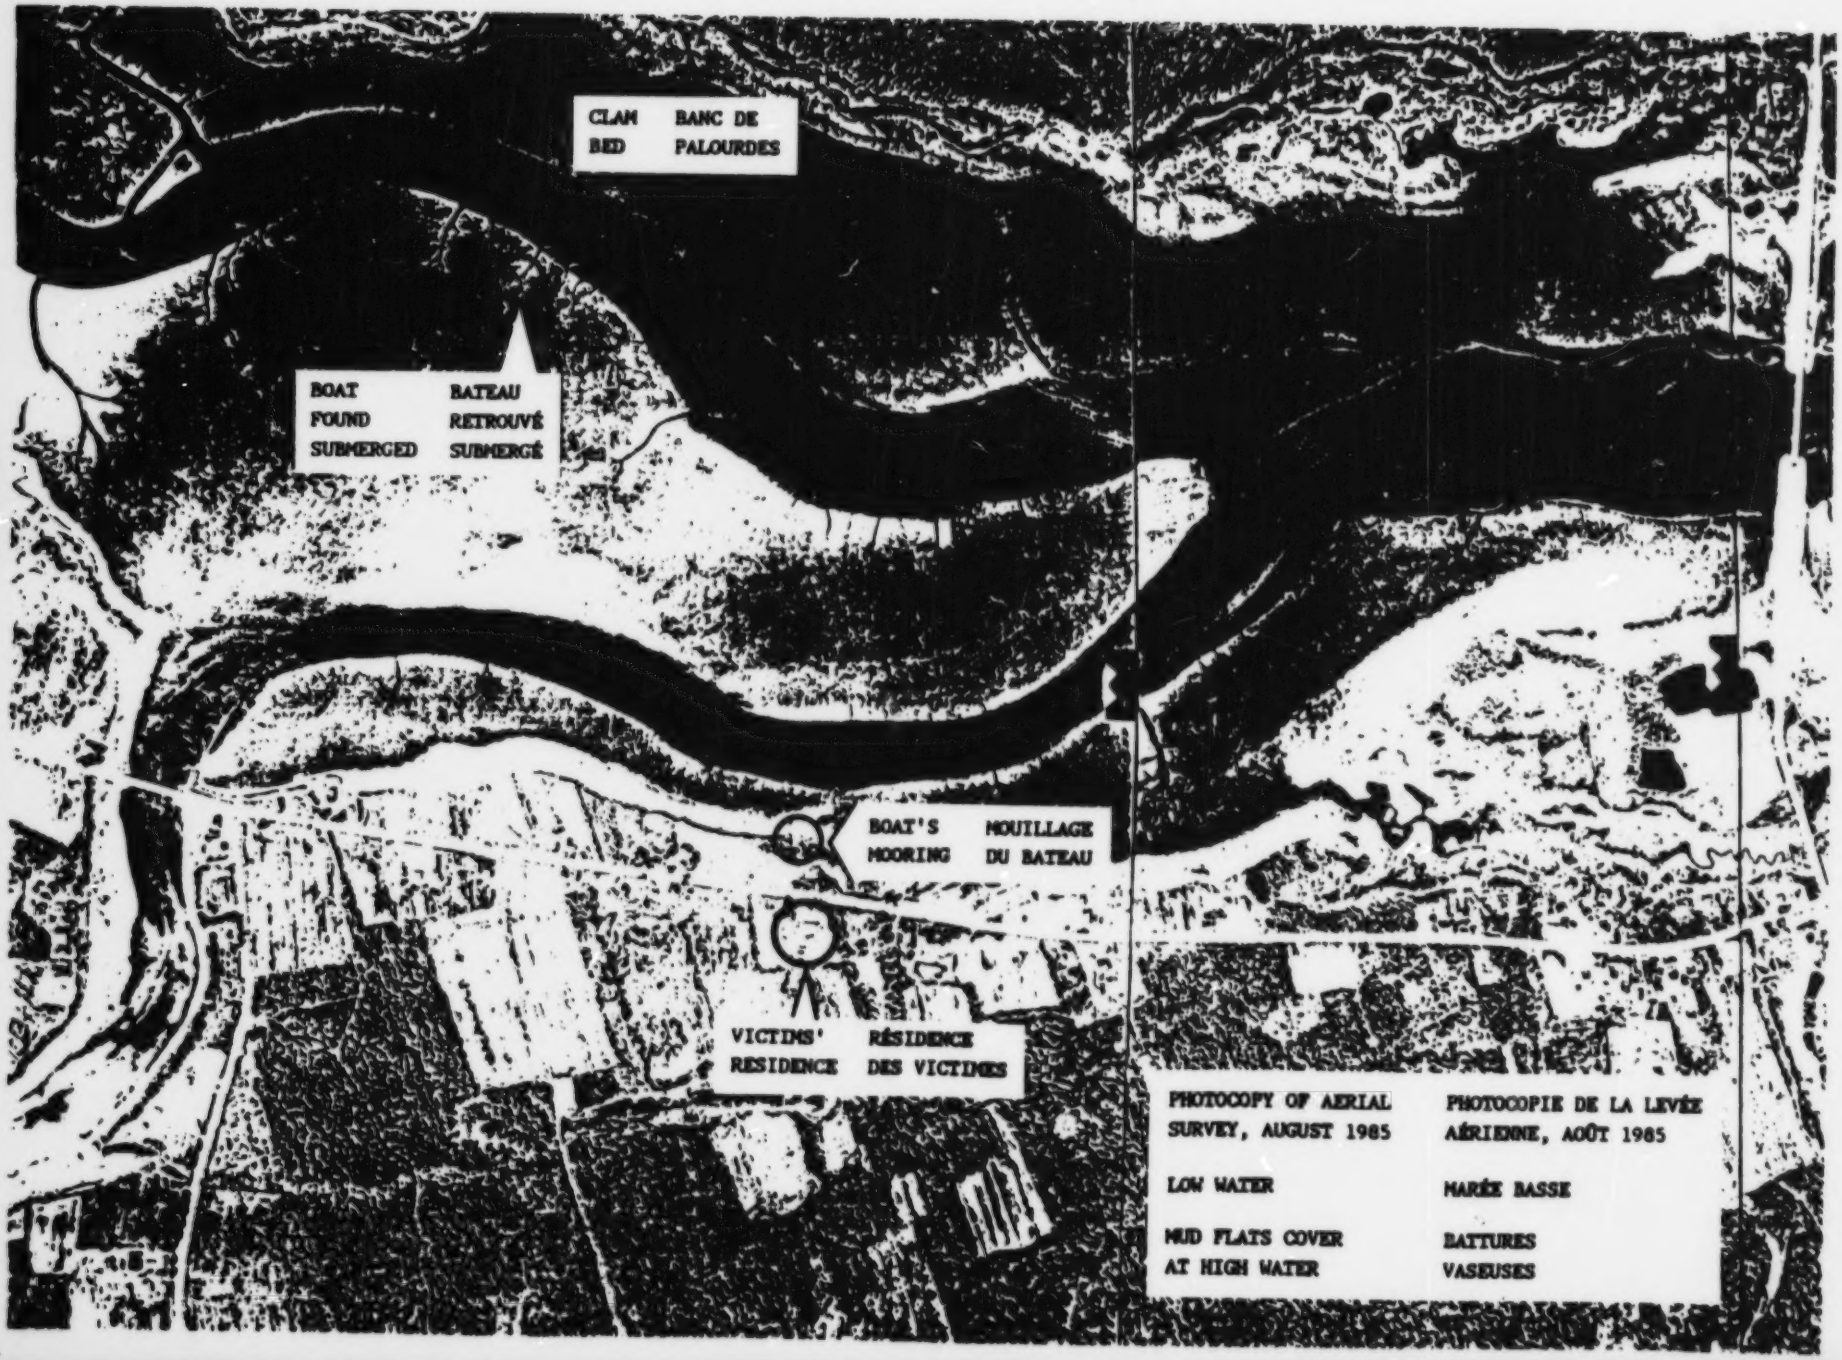
CLAM BED
BANC DE PALOURDES
BOAT FOUND SUBMERGED
BATEAU RETROUVÉ SUBMERGÉ
BOAT'S MOORING
MOUILLAGE DU BATEAU
VICTIMS' RESIDENCE
RÉSIDENCE DES VICTIMES
PHOTOCOPY OF AERIAL SURVEY, AUGUST 1985
PHOTOCOPIE DE LA LEVÉE AÉRIENNE, AOÛT 1985
LOW WATER
MARÉE BASSE
MUD FLATS COVER AT HIGH WATER
BATTURES VASEUSES
